FX-2000 Real Time Clock (RTC) Problem

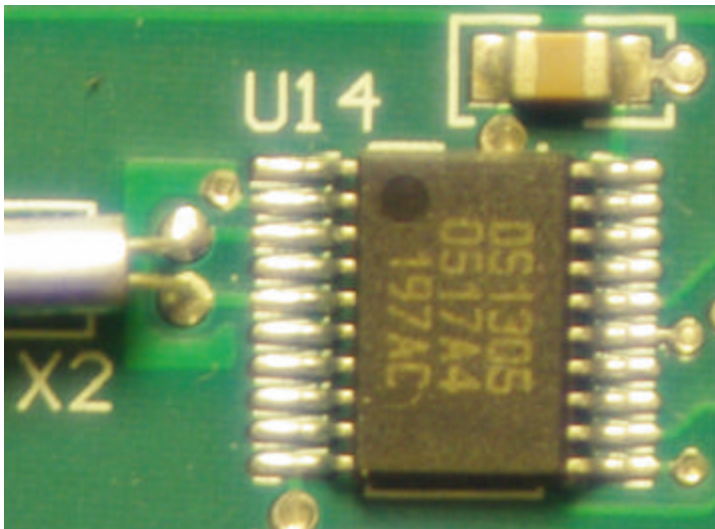
We have had a number of FX-2000 panels giving “**RTC supervision trouble**”. In some cases the panel date resets back to 1981 when the system is initially powered up.

This problem was investigated by engineering, quality control and purchasing departments and the problem that was found originated with a certain batch of Real Time Clock chips received from our suppliers with date code 0638. The chip is designated as U14 and is located at the bottom of the circuit board above the trouble buzzer.

Regrettably, if you experience the above problem, the only solution is to replace the main FX-2000 board.

New replacement boards can be ordered through the Customer Service Department using the following part numbers:

- RB-FX-2000MB FX-2000 Main PC Board 6 Amp (Compact Build)
- RB-FX-2000MB 12 FX-2000 Main PC Board 12 Amp (Compact Build)
- RB-FX-2000MB 12S FX-2000 Main PC Board 12 Amp (Large Build)
- RB-FX-2001MB FX-2000 Main Board 1 Loop Non-Expandable
