## QDV-1000 Digital Voice Module

This Technical Information Update applies to QDV-1000 Digital Voice Modules that were purchased between September 1, 2008 and April 23, 2009.

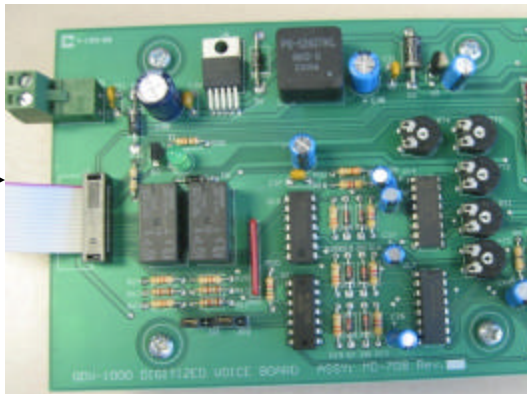
### Wrong Orientation

A small batch of QDV-1000 Digital Voice Modules that were manufactured with date **code 38/08** were assembled with the wrong ribbon cable orientation therefore they will not function as intended and will damage the QIF-5000 interface module if used. It is recommended that the QDV-1000 be replaced.

**Red Stripe**

We have identified the problem with the automated test method where the ribbon was not being properly tested; the test procedures have been altered to prevent this problem from reoccurring. If the QDV-1000 has the incorrect ribbon cable assembled, it is recommended that Customer Service be contacted and the QDV-1000 will be replaced under warranty.

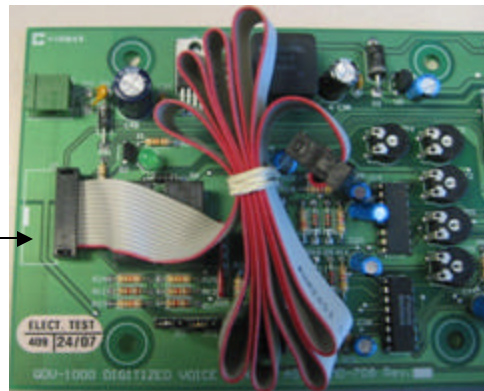
### Correct Orientation

**Red Stripe**
